Bearings and Drives

**Ron Brook - Rockwell Automation
presented at
Vibration Institute
Delaware Valley Chapter
January 27, 2000**

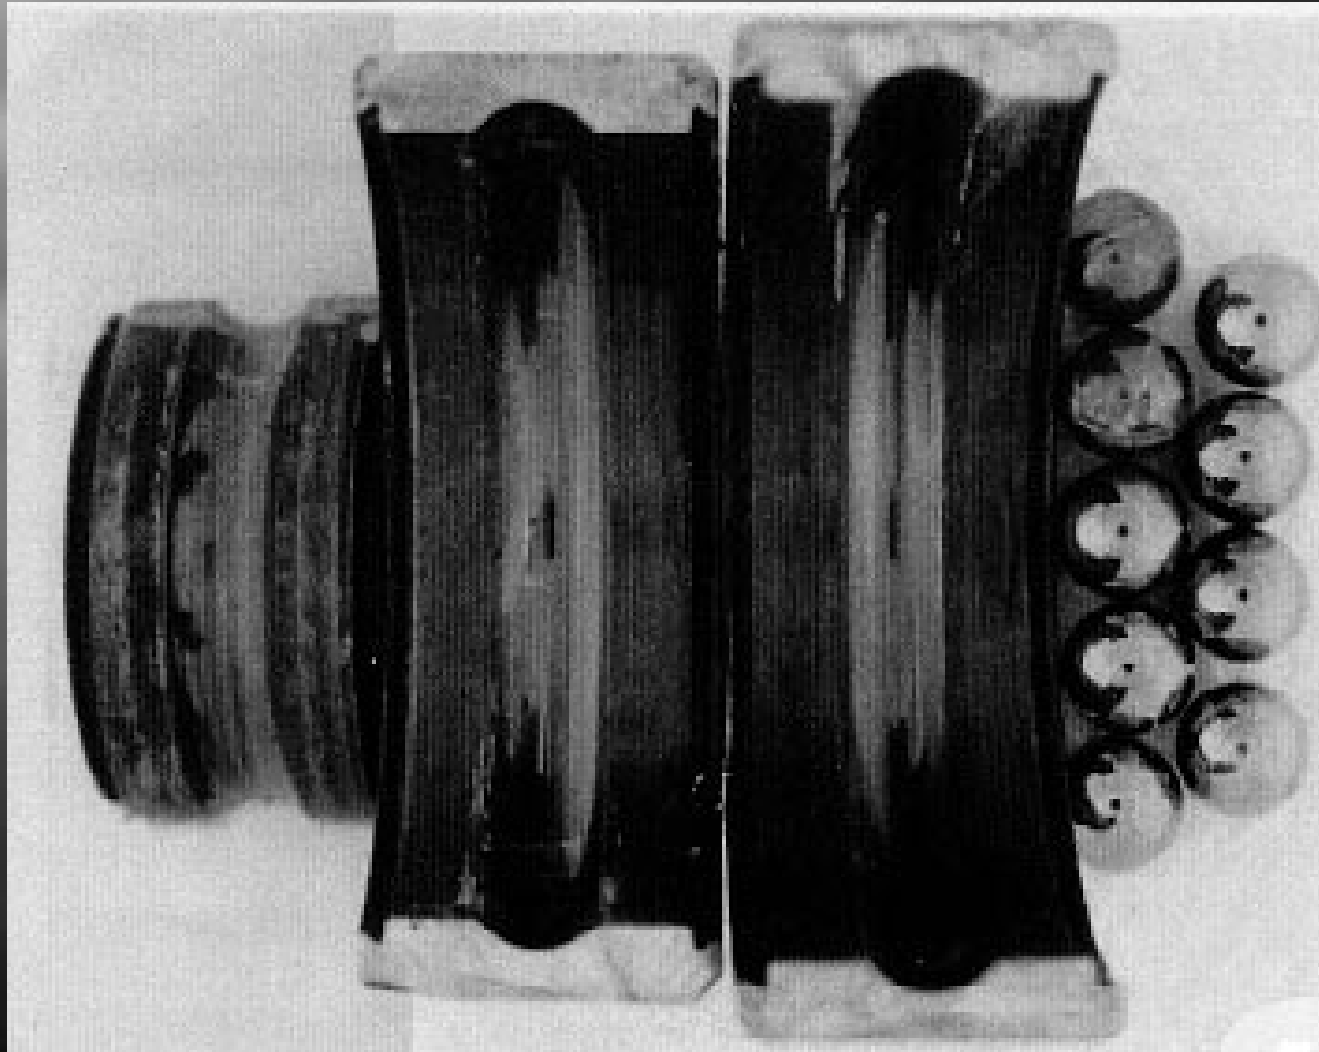
Damage Due To Lubrication Decomposition

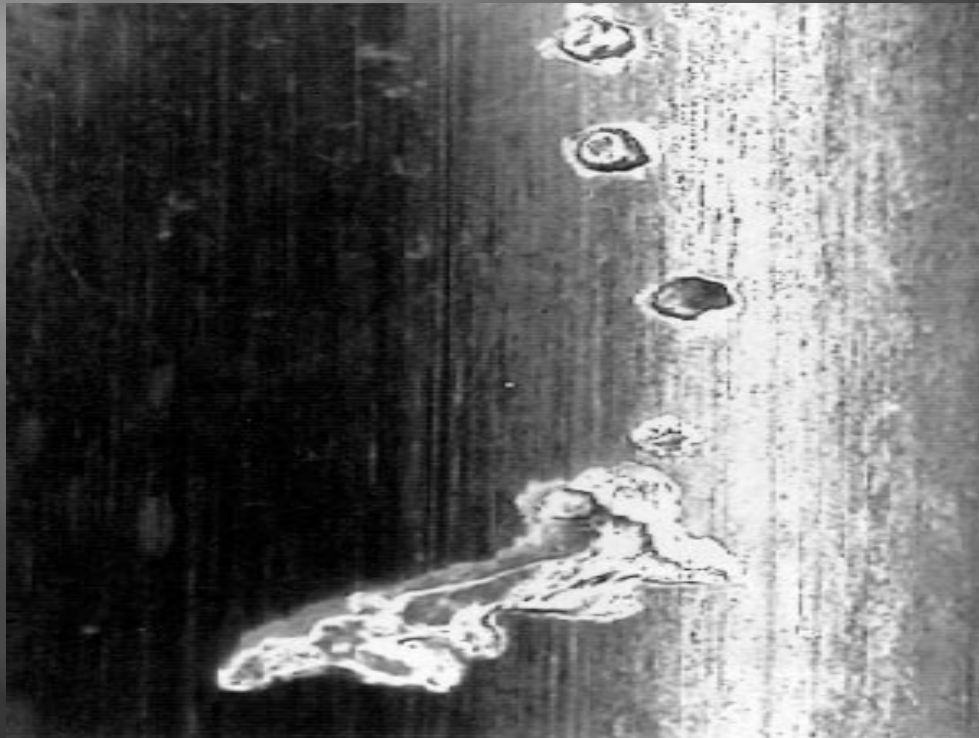
EDM

(Electric Discharge Machining)

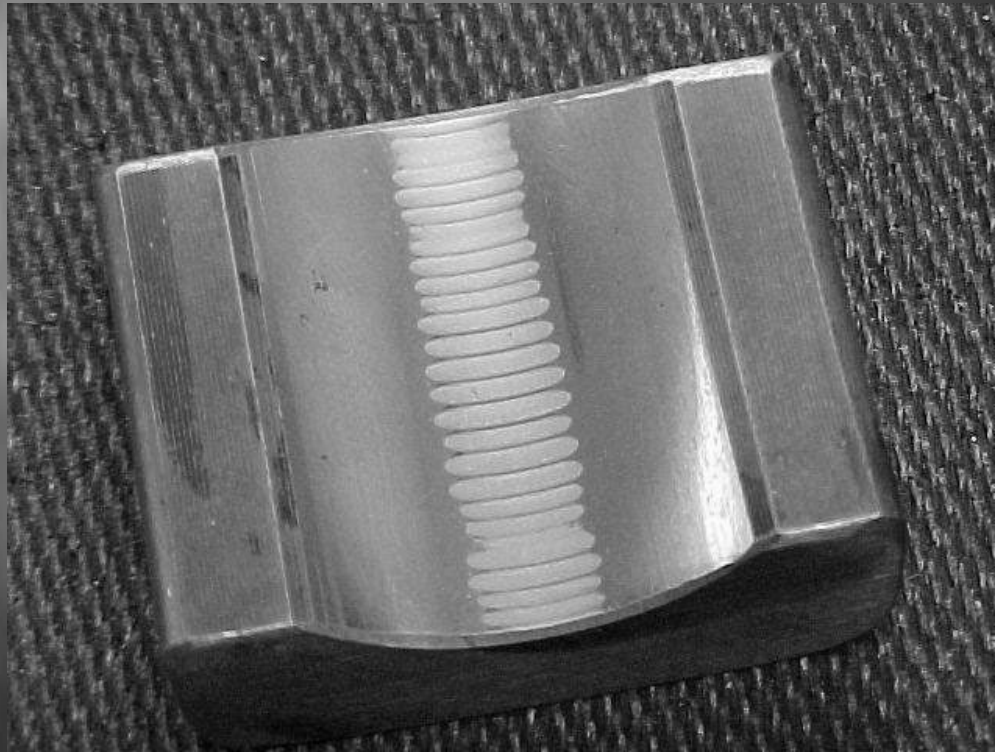
Bearing "Fluting" Long-Term EDM

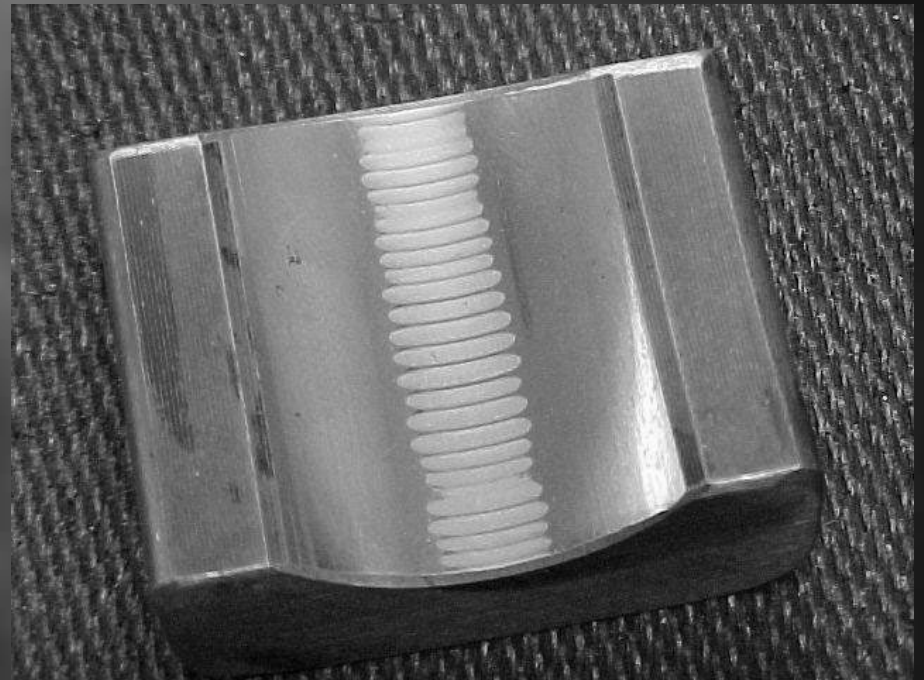
Case History #1

- Generator Bearing
- Multiple Failures
- Insulated Outboard Bearing

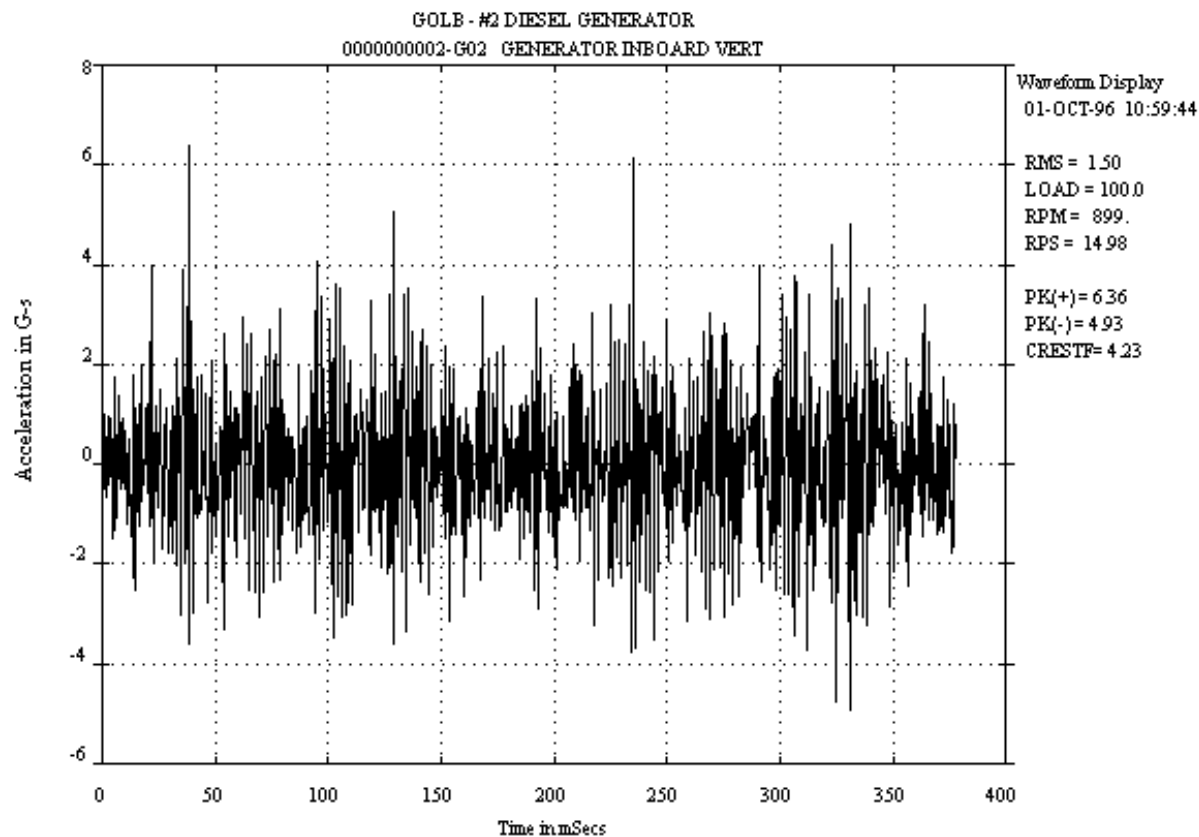
Time Waveform Analysis

- Peaks in excess of 6 G's
- Increase occurred over 3 months
- Third bearing change in less than 2 years

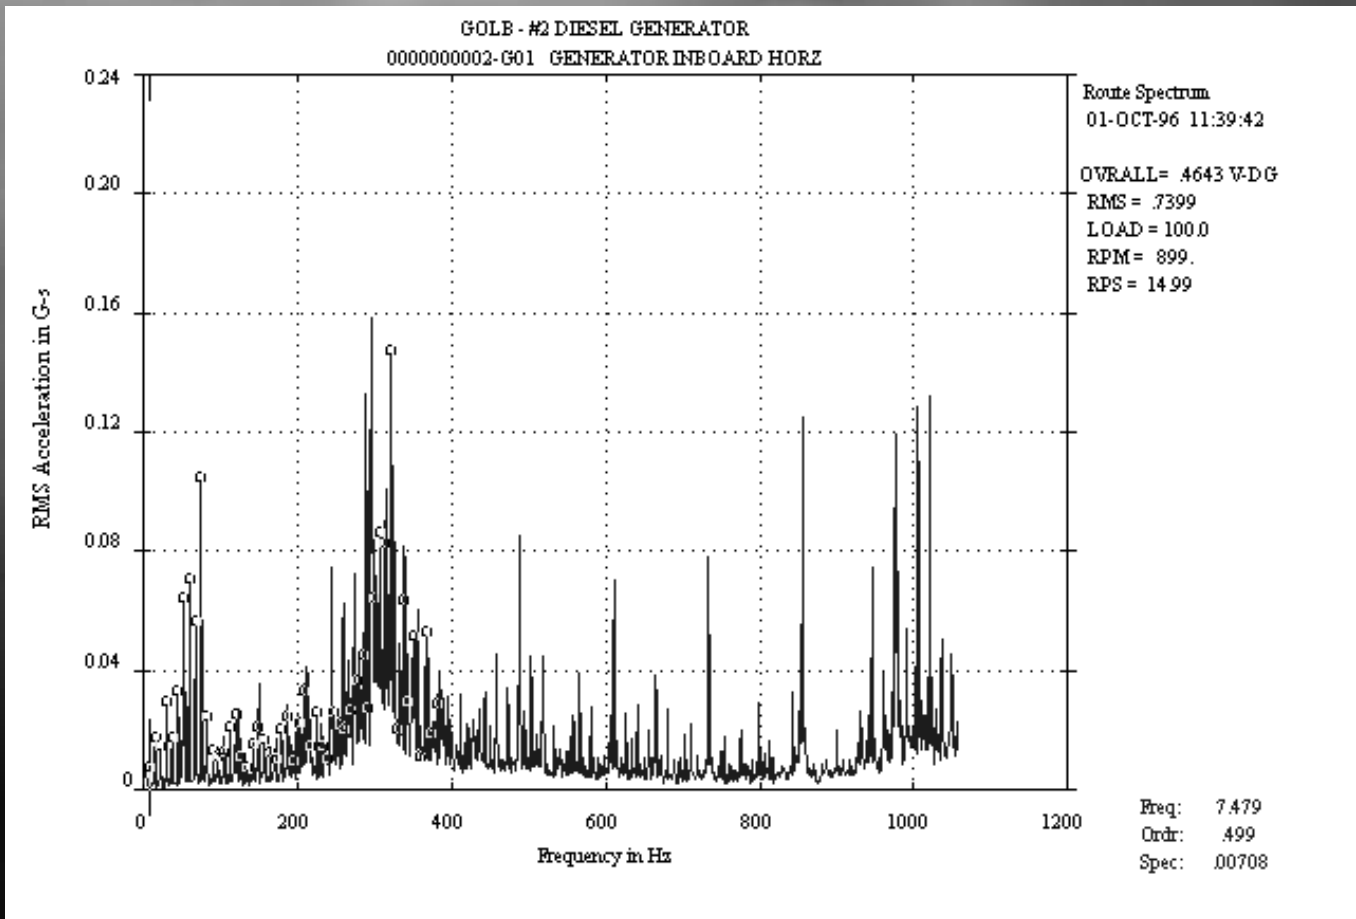
Spectral Analysis

- Low level G's in spectrum
- Non-synchronous vibration
- Higher frequency peaks not related to bearing frequencies

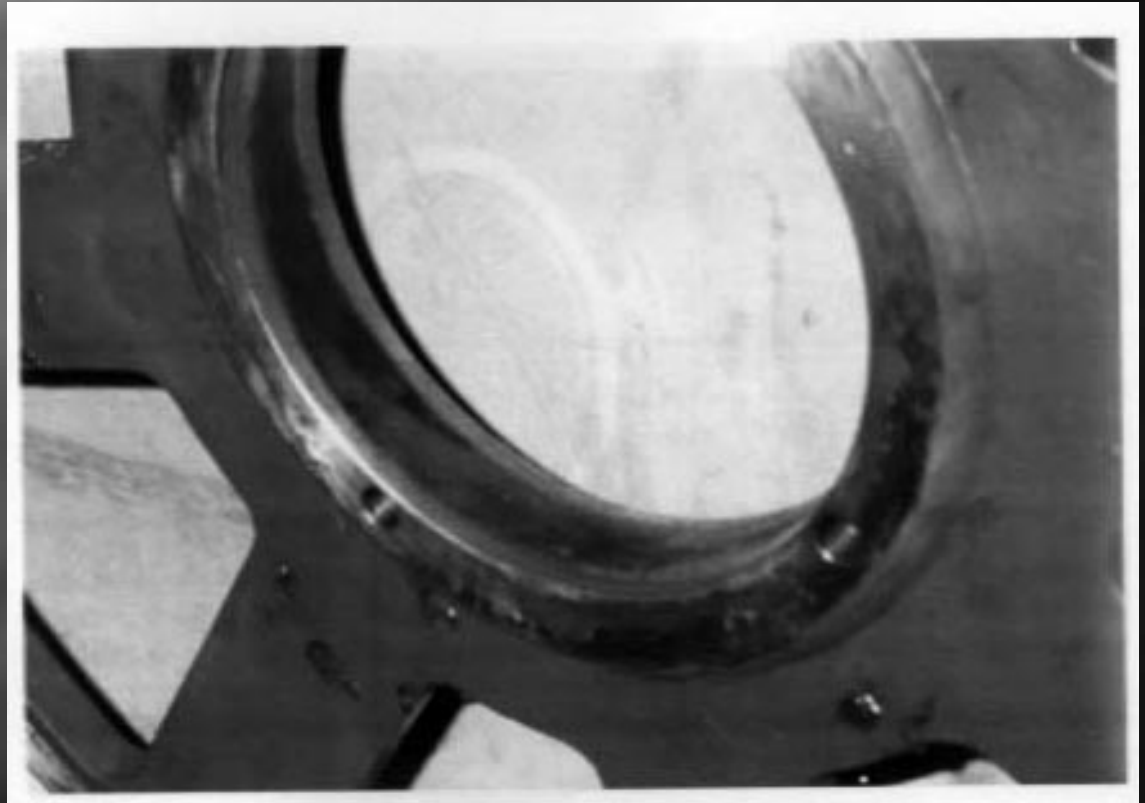
Generator Outboard Bearing Hub

- Outboard bearing insulation insufficient due to design of spoke - hub support
- 0.010" insulation "peeled" back during bearing installation
- New bracket designed to provide sufficient hub thickness
- New insulation ring over 0.5" thick

- Thin wall supports outer race
- Grounding brush would also work to solve this problem

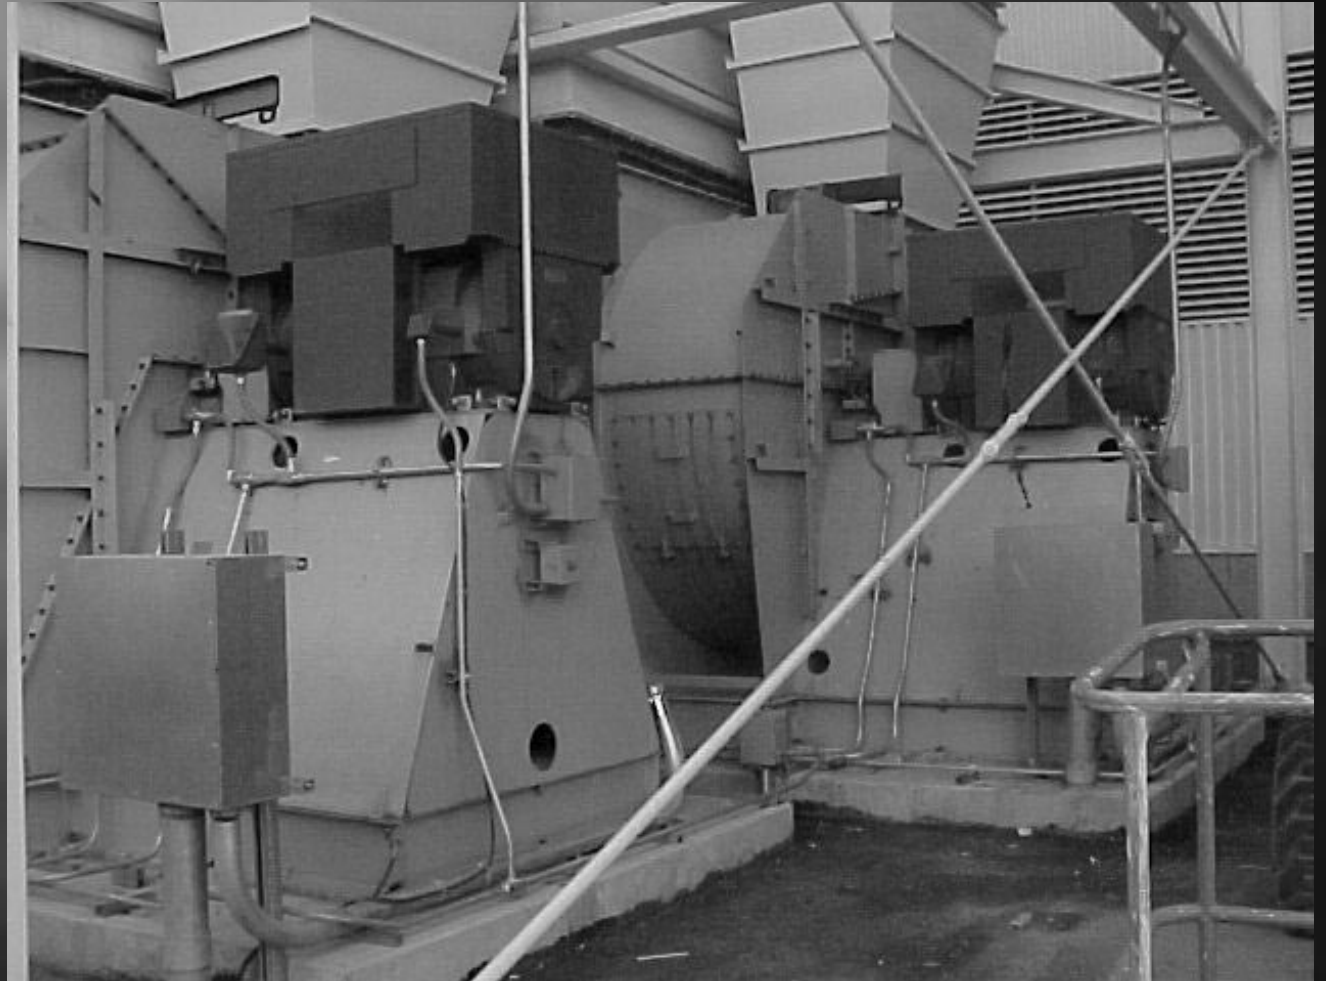
Electrical Fluting of Bearing

- Problem Occurring on Two of Eight Motors
- Outboard Bearing Insulated
- Inboard Bearing Damaged
- IGBT Medium Voltage Drives (460V)
- SCR Driven Heaters in Motor
- Coupling Insulated - Required by Process

- Insulate both bearings
- Place grounding brush on motor shaft
- An Investigation into grounding issue is pending

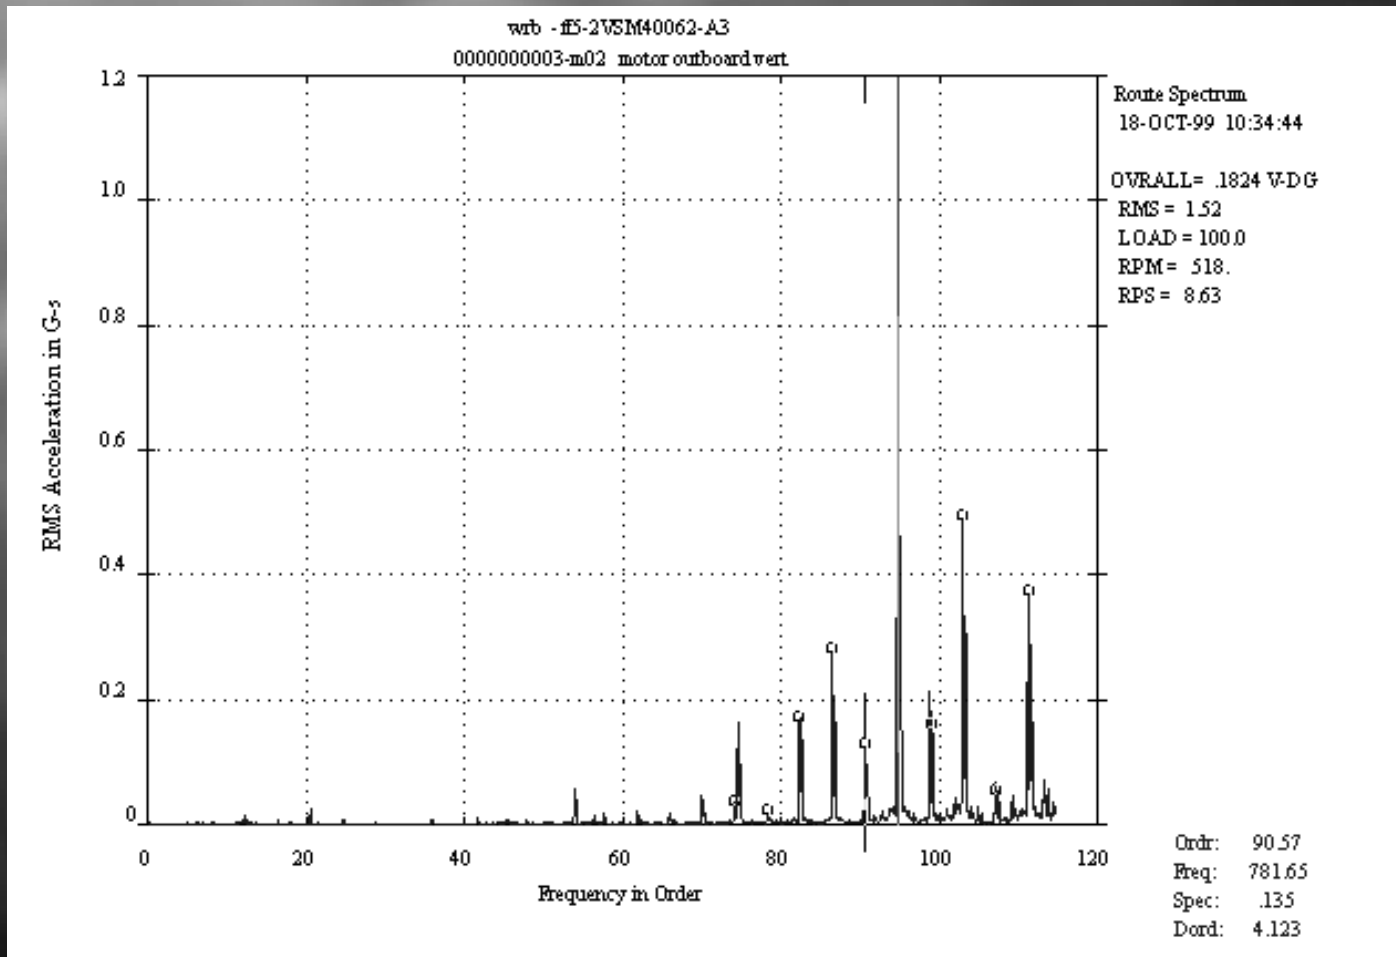
Vibration of Suspect Bearing

4.10 Modulation = BPFO harmonics

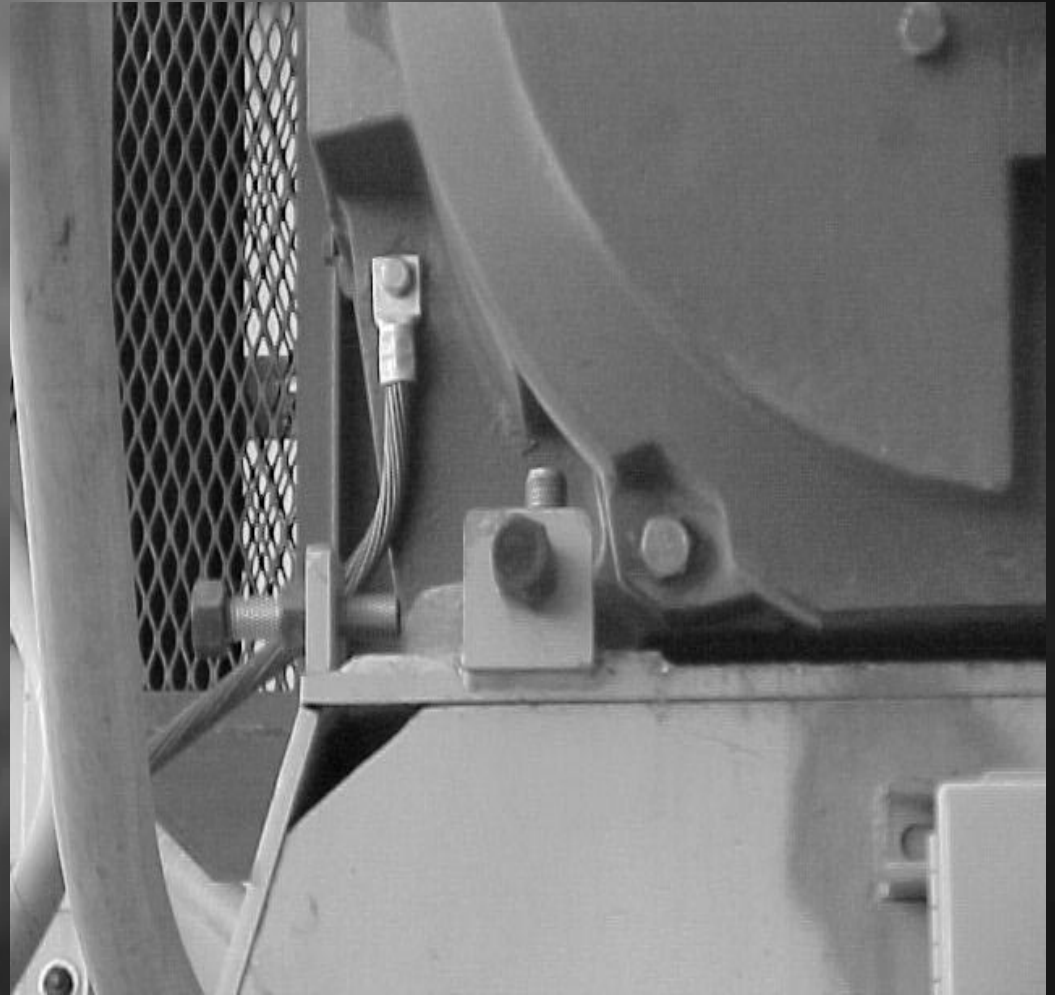
Grounding - Right or Wrong ?

- Cable size good
- Connection point good
- Connection continuity (?)

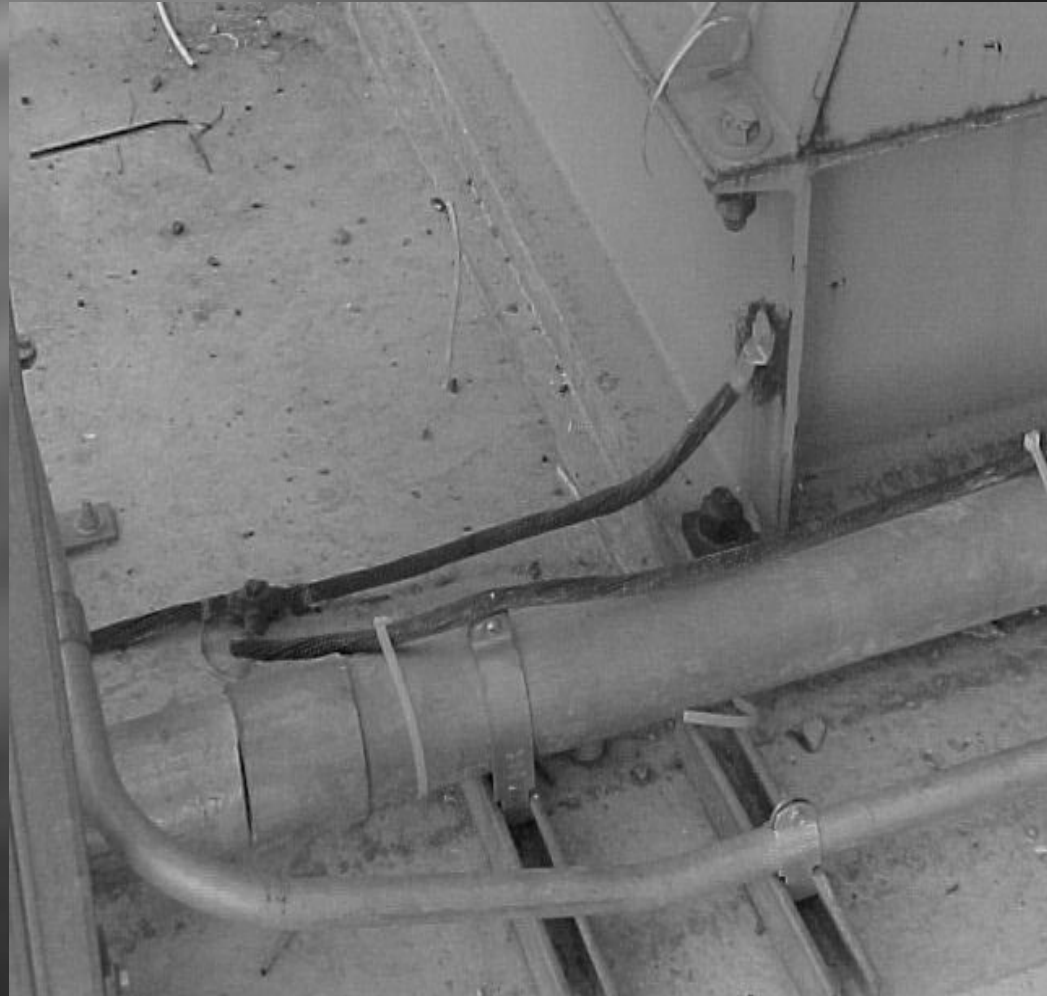
Grounding - Right or Wrong ?

- Cable weight identical to motor connection (?)
- Connection continuity (?)

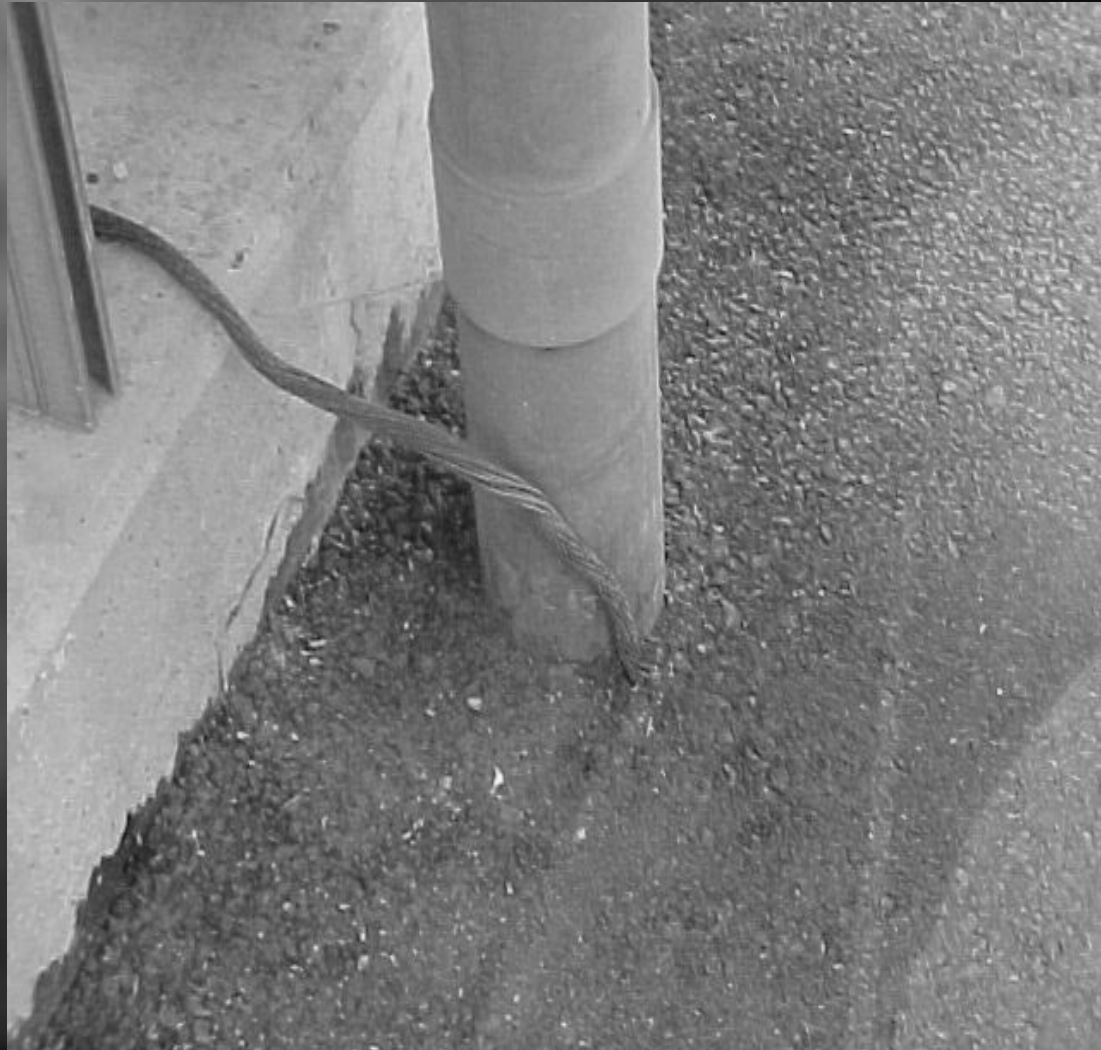
Grounding - Right or Wrong ?

- Connected to Plant Ground Grid (?)
- Large difference between #3 and #5 measurements

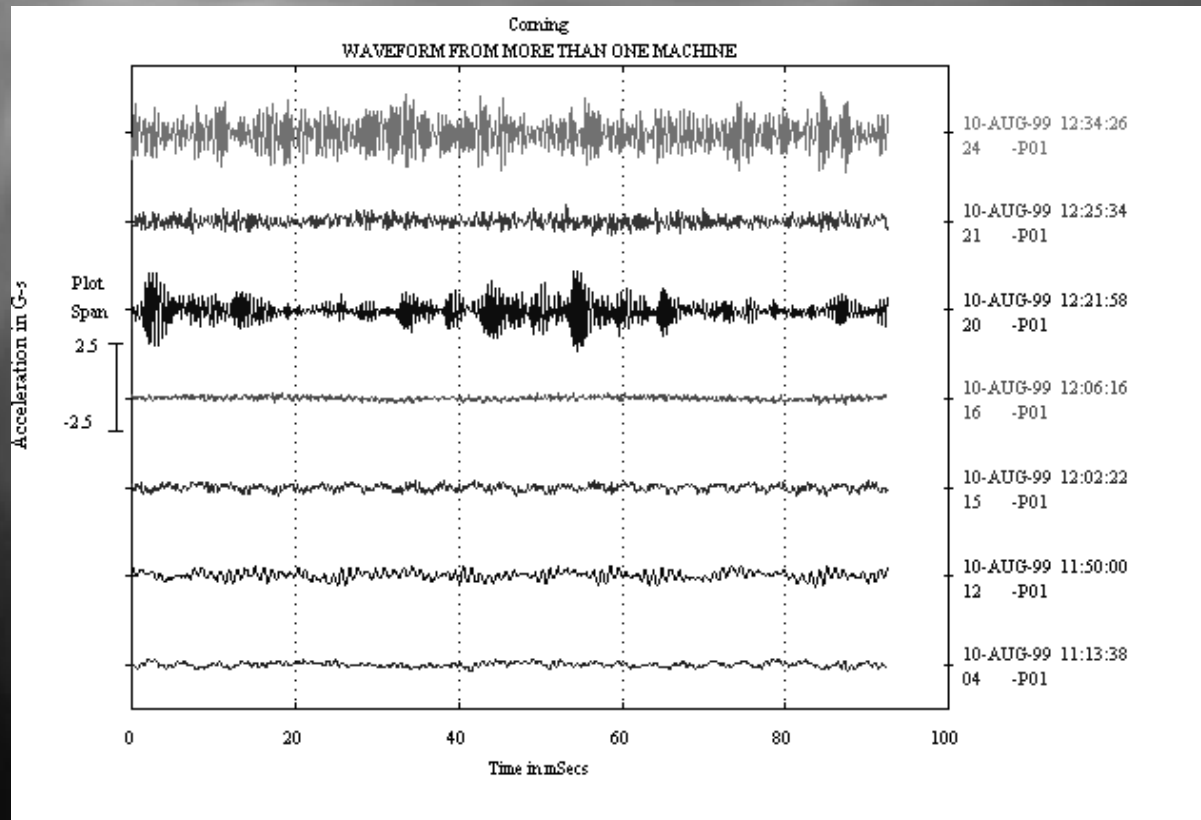
Motors in Service -Good or Bad?

- Evaluate motors in service
- All motors have outboard bearing insulated

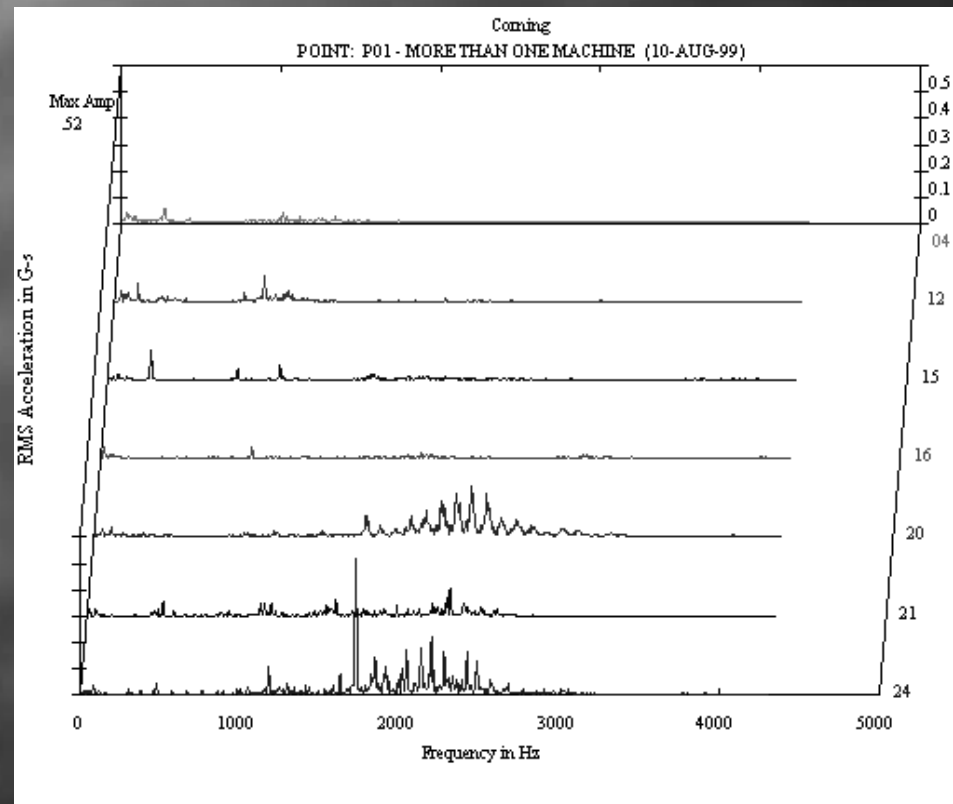
Motors in Service - Good or Bad ?

- Fluting evident above 2KHz on three motors
- Not all motors experiencing problems

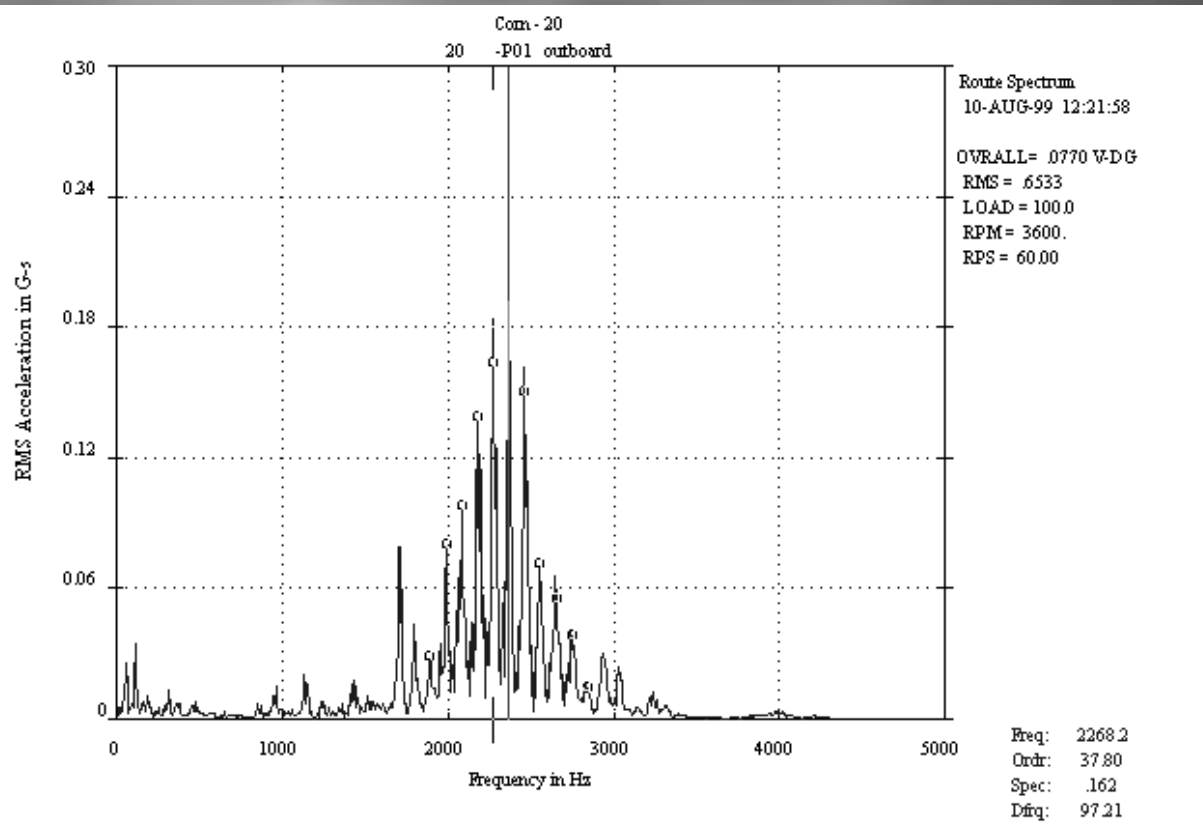
Identification of Bad Bearing

- Bearing modulation centered above 2kHz
- Sideband modulation occurring at 4.21 orders (BPFO)

- Replace motors with new farraday shield motors
- Investigate grounding (motor adjustable base made of high impact plastic). Only ground on the motor is conduit
