# CONDITION MONITORING OF COOLING TOWER FAN GEARBOXES

*Paul Donnellan, Innogy plc*

**Abstract:** *To reduce visual and environmental impact, modern power stations are built with induced draft cooling towers replacing the large natural draft cooling towers previously used. The ability of the cooling towers to provide adequate cooling for the main circulating water of the power station is affected by the availability of the cooling tower fans.*

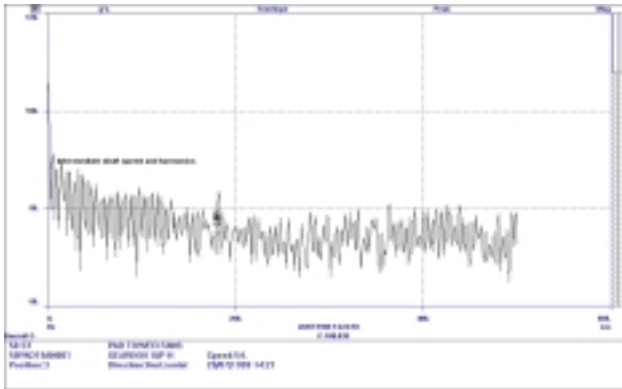
Figure 2: Envelope spectrum of gearbox output shaft accelerometer

Some gearboxes experienced single teeth failures on the intermediate shaft bevel gear. Metallurgical analysis of the damaged teeth suggested a manufacturing defect or a transient overload on the gear, possibly when the motor was started.

The defect was detected using Enveloped Signal Processing of the signal from the accelerometer mounted at the output shaft. Figure 2 shows the envelope spectrum, with harmonics of intermediate shaft speed indicating the repetitive event of a single tooth defect.

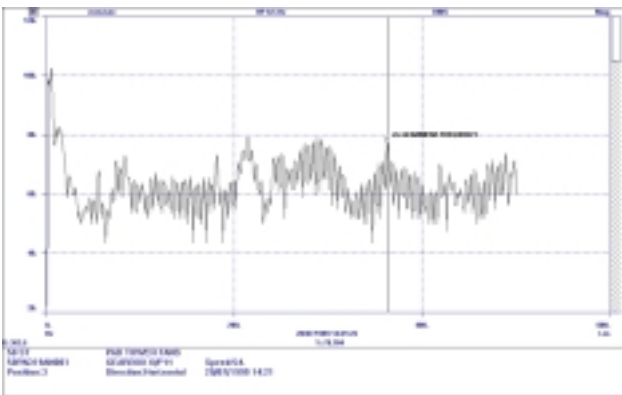
Figure 3: Velocity spectrum of gearbox output shaft accelerometer

The output shaft accelerometer signal is integrated to give a velocity reading. Figure 3 shows the velocity spectrum, with the 2<sup>nd</sup> harmonic of the input gearmesh frequency modulated by intermediate shaft speed, giving the characteristic

“sidebands”. The precise nature of the defect cannot be determined from this spectrum, but the change from a “healthy” reading would lead to a maintenance intervention.

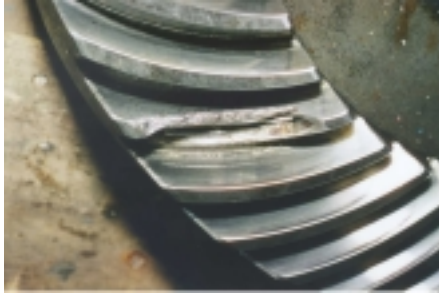
Figure 4 shows a typical gear with the damaged tooth clearly visible.

Figure 4: Damaged tooth on intermediate shaft bevel gear

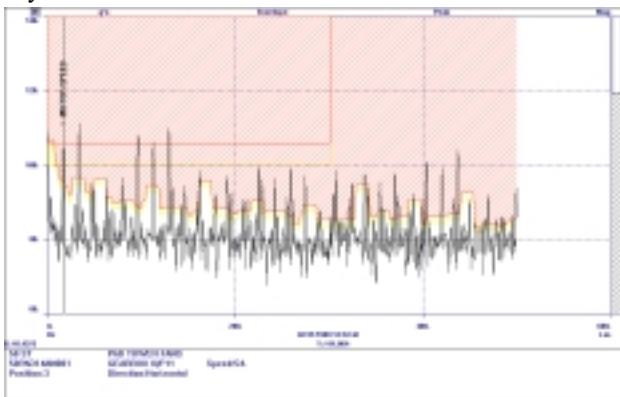
A gearbox was returned to service after repairs to gear teeth but failed soon after being installed. Using Enveloped Signal Processing an input shaft bearing defect was detected using the accelerometer mounted at the output shaft. Figure 5 shows the envelope spectrum, with harmonics of motor / input shaft speed and sidebands indicating impacting, typical of a rolling element bearing defect. In this case a more detailed analysis of the spectrum was needed, shown in Figure 6, to isolate the individual bearing component, but a defect is noticeable, even without such analysis.

Figure 5: Envelope spectrum with harmonics of motor / input shaft speed and sidebands

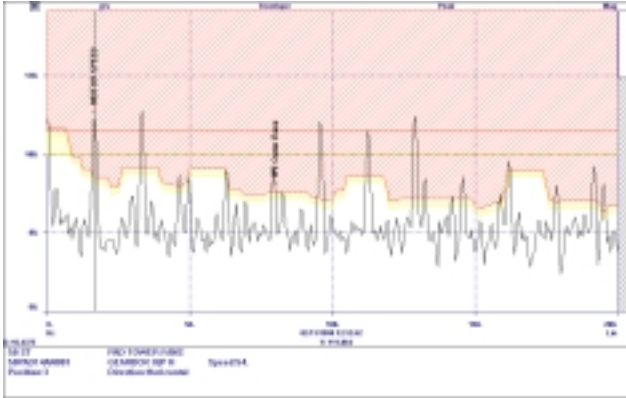
Figure 6: Detailed envelope spectrum showing gearbox bearing defect frequency

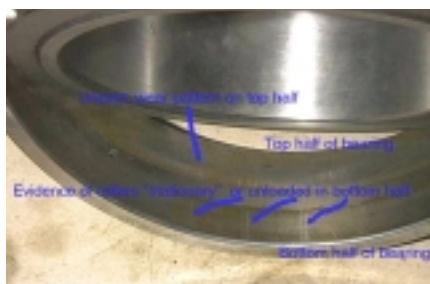
If the fans are left stationary false brinnelling damage can take place. Over long periods (>3 weeks) the thickness of the oil film reduces to the point where fretting corrosion can occur if water ingress occurs via the shaft seal. Such damage can occur during commissioning, when some fans run but others are left stationary for long periods.

Figure 7 shows an output shaft top bearing removed from a gearbox, with markings on the bearing outer race showing where the bearing had remained stationary. Enveloped Signal Processing is recommended for detection of these bearing failures.

Figure 7: Output shaft top bearing with markings on the bearing outer race

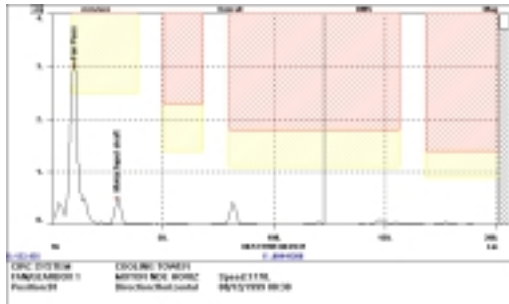
Waterlogging of fan blades can cause fan unbalance. Porous GRP material delaminates and small pieces break off inside the hollow fan blade, lodging at the end of the blades and blocking the water drain holes.

With no accelerometer installed on the gearbox, vibration on the driving motor was monitored using a hand held accelerometer. A harmonic of the fan speed triggered an alarm on the motor drive end bearing velocity spectrum reading. Figure 8 shows the motor drive end velocity spectrum, with the harmonic of fan speed labelled. The fundamental fan frequency is below the high pass filter used for the measurement, and therefore does not show on the spectrum.

Figure 8: Motor drive end velocity spectrum showing harmonic of fan speed
