Case Histories at a Nuclear Power Plant

By Edward Hudson - Entergy Operations, Arkansas Nuclear One

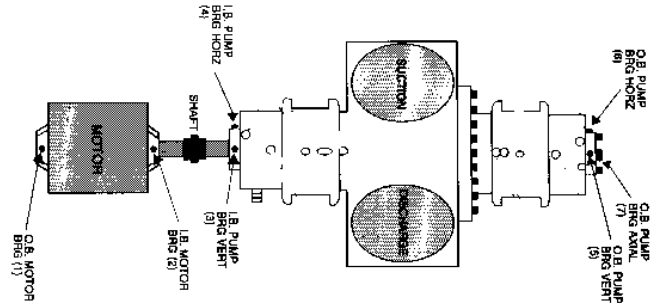
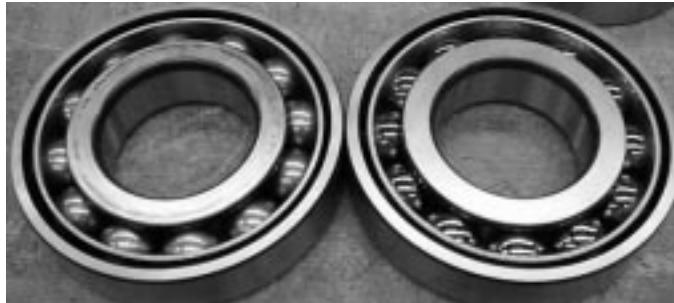
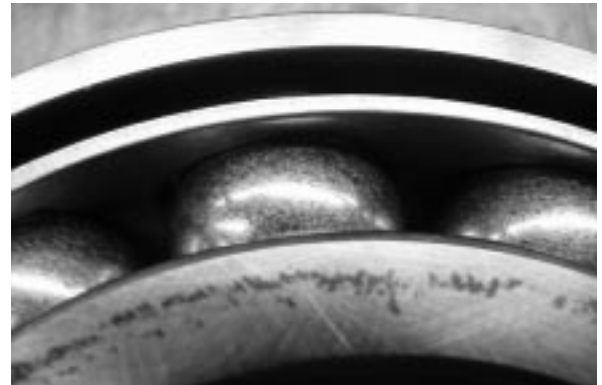
After the bearing temperature transients, the history of the components was researched, and it was determined that Predictive Maintenance had changed the oil viscosity from a VG-22 oil to a VG-46 oil a few months before this incident. The oil type change was initiated due to an analysis performed on the outboard thrust bearings, which indicated the need for a higher viscosity oil. The outboard bearings were experiencing "frosting" of the balls, which then caused excessive cage wear. This "frosting" is due to the lack of preload

on the face to face installed thrust bearings. This normally promotes ball skidding, but analysis of the bearing races indicated no skidding. Analysis suggested that impacting with the cage was causing the ball roughness. No preload could be applied due to pump design, but higher viscosity

Failure to adequately consider these parameters allowed an interference fit between the inboard bearing and its housing when the pump was asked to pump 270 deg. F. water with bearing cooling water below 60 deg. F. These factors contributed to an interference fit, which caused the bearing to bind in the housing instead of moving to compensate for axial thermal growth of the housing and the

shaft. The resulting compressive and axial loading on the inboard bearing caused excessive heat generation and the high temperatures experienced. It is suspected that if the pump had not been shutdown when the high temperature alarm was received, the inboard bearing would have failed due to fracture of the cage from excessive axial load.

A contributor to the event was the oil viscosity. In combination with the cold Service Water temperatures, the magnitude of the bearing housing shrinkage and the bearing fit (at the upper limit of the tolerance), the heavier oil viscosity resulted in greater heat generation. The higher viscosity causes internal heating which causes greater thermal expansion of the bearing race, making the interference fit worse.

The pumps were modified to correct the problems. This modification included:

- Identified and verified proper critical dimensions in both pumps.
- Returned inboard bearing housings to original cast iron material.
- Replaced inboard bearings with 6217 C4 bearings (from C3), which have larger internal clearances.
- Increased ID of inboard bearing housing to a modified H7 fit in the upper half of the tolerance band.

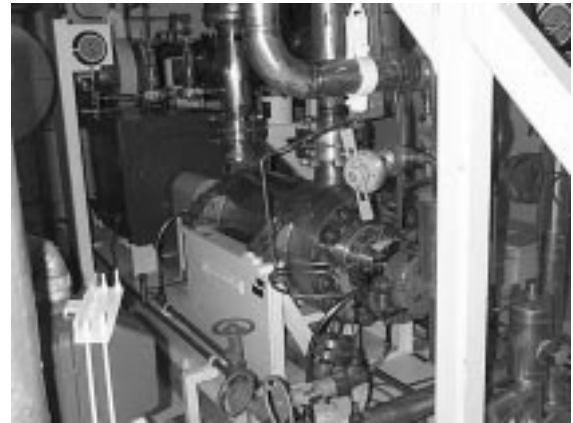
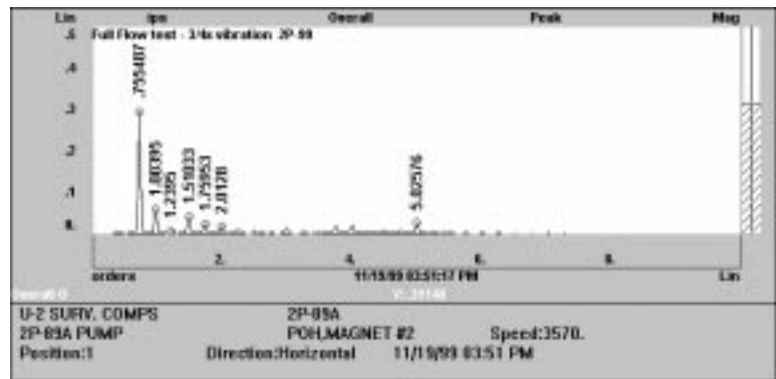
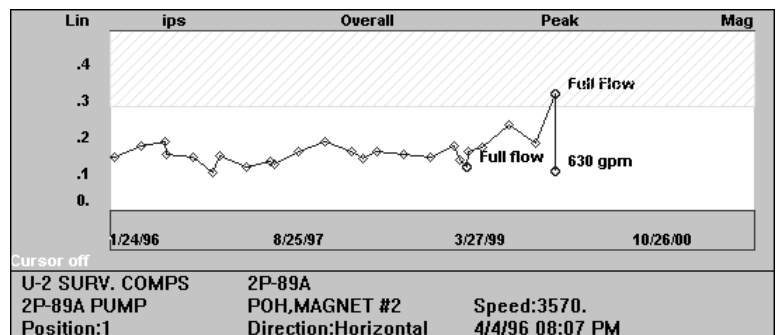
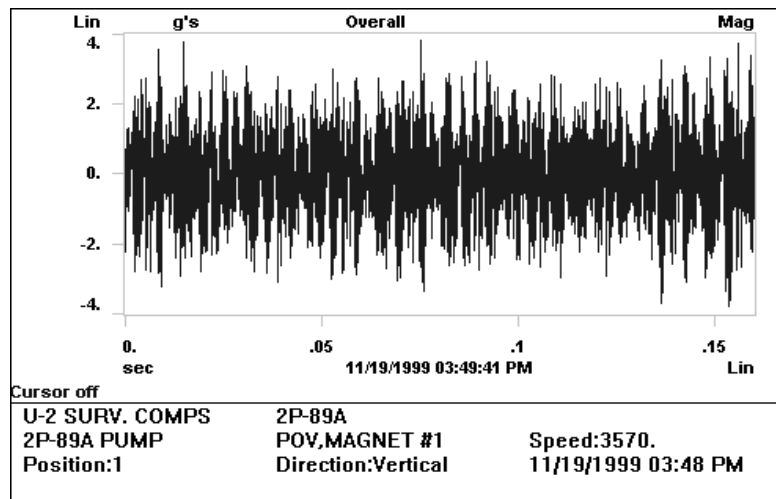
2P-89A is a Ingersoll-Rand 9 stage high pressure injection pump driven by a Allis-Chalmers 600 hp 3600 rpm motor. Normal quarterly testing is done through a minimum recirculation line at a very low flow rate. The pump is tested at Full Flow (750 gpm) every 18 months. While testing the pump at Full Flow conditions during a recent unit shutdown, vibration amplitudes were above the acceptable normal range on the pump outboard horizontal point. Analysis of the vibration data indicated the vibration increased from .117 ips to .320 ips. The increase in vibration occurred at 3/4x running speed (2685 cpm). This 0.75x frequency was predominate on all points during the Full Flow test at 775 gpm, but was not present during a subsequent test run at 630 gpm. The 3/4x frequency was not present during the previous Full Flow test done 6 months earlier.

Detailed data was collected on the pump during the Full Flow test, including high-resolution spectrums and waveforms. We theorized that the 3/4x vibration was a rub, but the waveforms did not have any rub characteristics.

The history search also revealed that this frequency was observed once before on another High Pressure Injection pump, 2P-89C, during a Full Flow test in April of 1994. The .75x frequency (during that test) also disappeared as flow was decreased on the pump. The amplitudes of the .75x frequency approached .7 ips on some points. Significant Analysis was done at that time to explain the frequency. 2P-89C also failed its DP criteria during that full flow test and was declared inoperable. 2 months later, 2P-89C failed a seal and seized up during a system integrity test.

- *The subsynchronous vibration could be the result of hydraulic "swirl", excited by interstage leakage. It is noted that as the pump flow is reduced, and interstage pressure is increased, the .75x energy abates. The increased interstage pressure provides the condition for the casing rings to act like small hydrostatic bearings; dynamic dampening, known as the Lomakin Affect also occurs as the ring differential pressure increases.*

- *This condition could also be internal contact between the impellers and casing rings, or balance drum and sleeve. It is noted that the vibration is highest on the outboard/thrust bearing, possibly pointing to the drum and sleeve.*

- *Pumps of similar construction, at another installation, have exhibited this .75x vibration. Disassembly revealed opened clearances due to rotor contact at very high BEP flows. The "wide open" clearances made it difficult to define if the .75x was a rubbing or high interstage leakage hydraulic subsynchronous swirl. The Pump is essentially performing hydraulically to the original design performance curve. The .75x may be rubbing contact at high flows, lower delta-P, between the drum and sleeve face. It is recommended that the axial balance drum setting be checked at the plants earliest convenience.*

During the pump rebuild, excessive internal clearances were found at the wear rings.

With this information from the earlier analysis on an identical pump, and the absence of rub indications on the waveforms, it was concluded that the indications were the result of recirculation or interstage leakage. These phenomena are most likely caused by axial mis-positioning of the pump rotating element during the outboard bearing change.

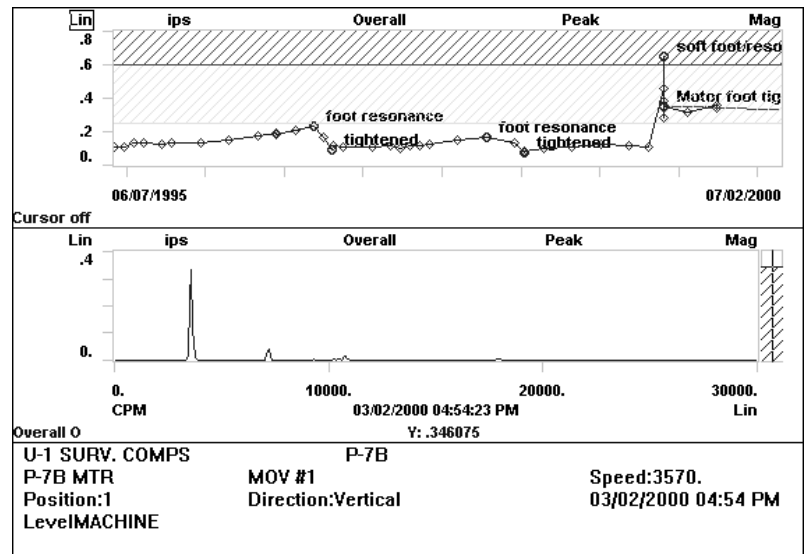
P-7B is an Emergency Feedwater Pump used to send cooling water to the plants steam generators for cooling of the Reactor Coolant System in the event of a loss of conventional cooling. Vibration data is collected on the motor and pump during routine surveillance. In 1996 it was noted that vibration amplitudes were trending up on the outboard motor vertical point. No change in amplitudes was noted in the axial or horizontal direction. All of the increase was at the motor running speed. The bearing is a plain journal bearing, and oil analysis did not indicate any problems. The motor feet were tested for a developing soft foot, and none was found, but it was noted

that after the foot was re-tightened the vibration returned to normal. We began to suspect a foot-related resonance. In 1998 vibration amplitudes started trending back up. The right outboard motor foot was tightened again, and again vibration returned to normal. A scheduled pump rebuild was carried out in 1999, and the motor was completely removed for access. Vibration amplitudes on the outboard motor vertical point were very high during post maintenance testing. All other points were normal. A soft foot check was performed, and no problems were found. Testing was performed which consisted of loosening and tightening the motor foot bolts with the motor running. It was found that vibration amplitudes on the outboard vertical point could be significantly affected by bolt tightness, but no amount of tightening or loosening could return the vibration levels back to the previously low level. We have theorized that the motor foundation has powdered grout or voids under the plate that is causing the changing stiffness and we can now, no longer move the resonance far enough away from the running speed to achieve the previously low levels. Maintenance is scheduled to check for this problem and do more troubleshooting in the near future.

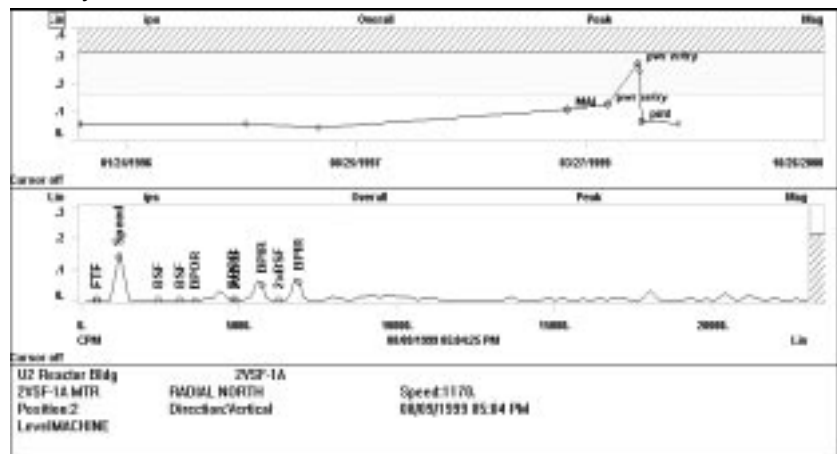
2VSF-1A's bearings were changed out while the unit was at power between the dates of 8/10/1999 and 8/15/1999 via a combined site effort. Upon disassembly of the motor, electricians noted that a winding heater lead was broken inside the "opposite drive end" of the motor. The following is documentation of the broken heater lead and possible cause.

The heater lead failure was caused by the wires that feed the internal motor heater on 2VSF-1A making contact with the internal rotor fan blades in the outboard end of the motor. Although the heaters (3) are secured in place with clips, the heater wires going to the heater box termination on the outside of the motor are free and un-tethered. They run between the outer side of the stator windings and the motor casing. The heater wires are intentionally left long to allow for the installation of the endbell. The problem arises when the heater leads are not gathered and pulled tight inside of the termination box when the endbell is bolted in place. This allows the excess wire to gather at the end of the motor in the endbell area, adjacent to the rotating fan blades. This is what caused the heater lead to contact the rotating element in 2VSF-1A. Because the heaters are attached to the endbell it is hard to judge the slack left in the heater wire when the endbell is bolted in place on the end of the stator. There is no way to visually check to see that the wires won't make contact with the rotor fan blades. One way to make sure that the slack is removed from the wire is to gradually pull it into the termination box as the endbell is being installed, and pull it tight and secure it in the box with a tie-wrap or tape after the heater termination is made. Although the wires' proximity to the fan blades can't be visually checked, it can be reasonably assured that pulling them tight in the box will keep them out of the rotational path of the fan blades on the inside of the stator. The important thing is to prevent any excess wire from spooling down into the endbell.

Inspections revealed the heater lead had contacted the motor rotor fan fins. This contact rubbed a significant amount of metal (aluminum) from the fins and wore through the heater lead.

When the drive end bearing was removed from the motor shaft, it felt rough when turned by hand and showed a tendency to "lock up". The opposite drive end bearing felt smooth when turned by hand. New bearings were installed in the motor, the heater lead was repaired, and the motor was reassembled. Special care was taken to pull the excess heater lead wiring out of the endbell into the termination box to prevent reoccurrence of contact with the motor rotor. Post Maintenance vibration testing indicated acceptable amplitudes and the fan was declared operable.

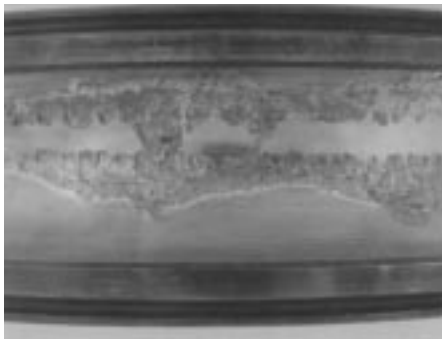
NTN Analysis:

The NTN report concludes that the bearing failure mode is lubricant deterioration and contamination, which lead to heavy wear, raceway and rolling element flaking, smearing and debris damage. The size, shape, depth, and regularity of the damage is fairly common in bearings that have been subjected to electrical arcing damage.

The expected life of this bearing is on the order of 12 years or greater. During disassembly it was found that a motor heater lead had contacted the motor rotor cooling fan fins, causing wear of the fins and generation of a large amount of aluminum dust. It is concluded from the NTN bearing analysis that arcing inside the bearing from the energized heater lead rubbing against the rotor fins and generation of aluminum dust contaminating the bearing grease were the primary causes of the bearing failure. The heater's are interlocked to deenergize when the motor is started. This

fan was started and stopped several times after the bearing change in 2R12 and the heater lead was automatically energized each time the motor was stopped. The partially worn lead would then have caused arcing against the rotor fins and through the bearings. Based on the amount of wear on the rotor fins, the heater lead rubbed for quite some time before complete separation occurred. Even without the arcing occurring, the aluminum dust contamination of the grease would be sufficient to cause the degradation seen in the bearing.

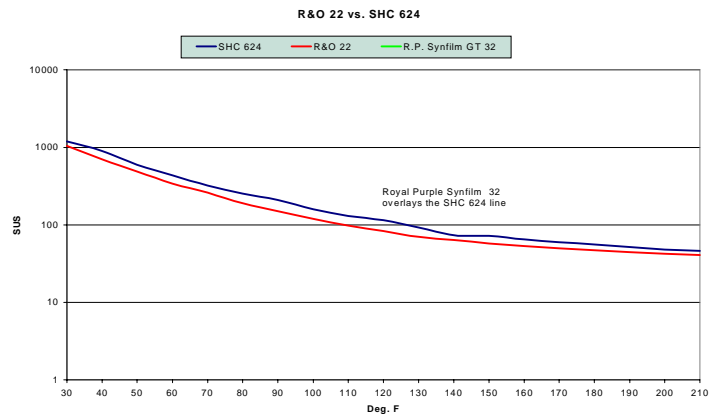
In certain situations, the better friction characteristics can allow a component to run cooler as well. Recently, we needed to specify an oil for a component that must operate in several extremes of temperature. The bearing cooling water temperature ranges from 33 deg. F to 121 deg F. depending on the time of year. The fluid being pumped can range in temperature from 70 deg. F. to 270 deg. F. A mineral oil that met the bearing manufacturers recommended minimum viscosity of 70 SUS for all operating conditions did not exist. Our evaluation turned to synthetics and a Mobil SHC series oil was found that met the requirements. As an added benefit, after the oil was installed it was found that the bearing temperatures ran from 10 to 15 deg. F cooler with the synthetic oil installed.
